CHEMICAL DEGRADATION OF POLYETHYLENE IN CONTACT WITH CHLORINE, DIFFUSION LIMITED OXIDATION ASPECTS

Bruno Fayolle^a, Clémence Devilliers^b, Lucien Laiarinandrasana^b,
Emmanuelle Gaudichet-Maurin^c and Jean-Marc Lucatelli^c

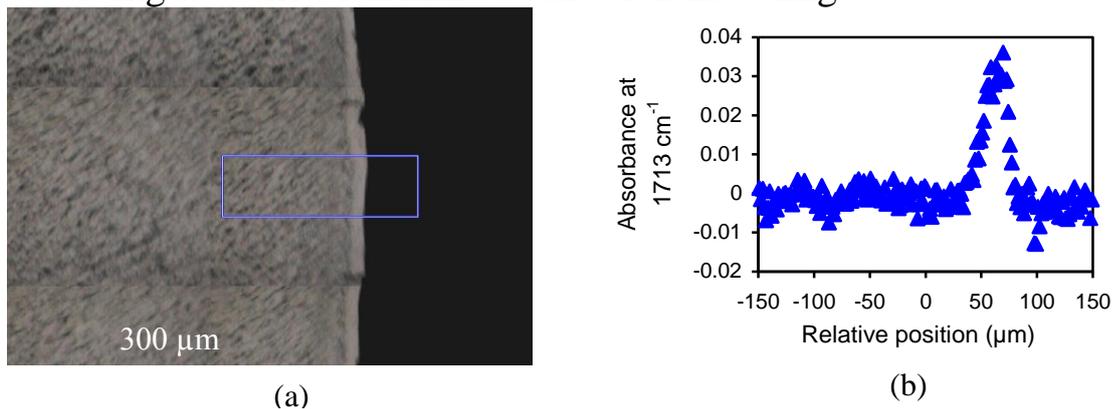
Figure 1: a) section of a thick sample exposed during 333 days in contact with a 70 ppm chlorine solution at 40°C, observed by optical microscopy (the blue rectangle corresponds to the analyzed zone by FTIR mapping) b) Carbonyl absorbance through the section in the blue rectangle.

Carbonyl profiles as a function of time of exposure for several chlorine concentrations are assessed using different tools as ATR-FTIR imaging. An example of carbonyl cartography by ATR-FTIR imaging is shown in Figure 1. The thick sample has been exposed during 333 days in contact of 70 ppm chlorine solution at 40°C. Thanks to optical microscopy, a brittle layer with cracks of 50 µm thick appears clearly. In a same time, FTIR mapping by following carbonyl absorbance at 1713 cm⁻¹ put in evidence an oxidized layer having a thickness close to 50 µm. As a result, brittle layer

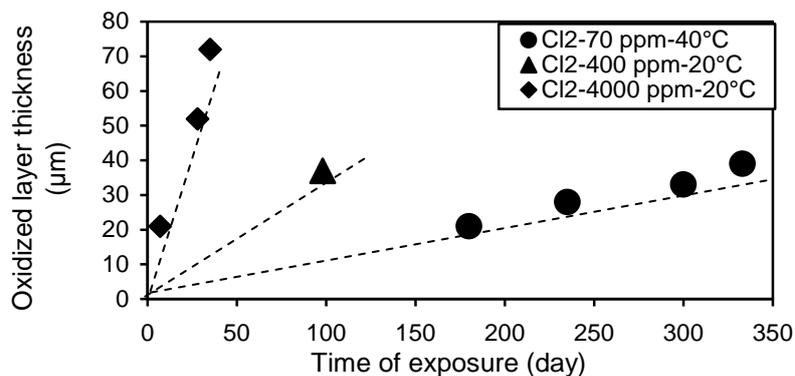
Figure 2: Oxidized layer thickness as a function of exposure time for three exposure conditions.

thickness which can initiate pipe failure can be assessed precisely by FTIR mapping during exposure. Figure 2 shows oxidized layer thickness changes as a function of time exposure for three exposure conditions: oxidized layer increases linearly with time and the corresponding slope is proportional to chore concentration. These results will be discussed according to a diffusion limited oxidation modeling.
